INSPECTION REPORT
8042 Oak Grove Road
Bloomington, MN

INSPECTED BY
Home Inspector Bloomington
Home Inspector Bloomington LLC
Home Inspector Bloomington LLC

4/29/2026

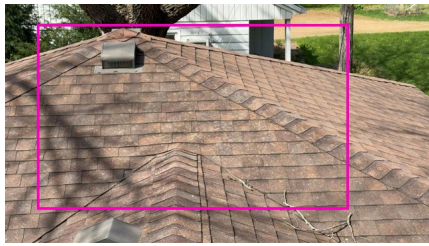
1.1 Item 1 (Picture)

(2) A localized area with circular discoloration was observed at the time of inspection, however no major damage was noted. Determining storm damage goes beyond the scope; further evaluation is recommended by a qualified person or contractor as needed.

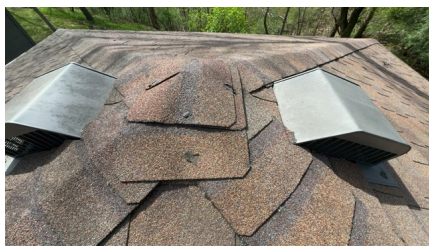
1.1 Item 2 (Picture)

(3) An exposed localized nail head was observed at the time of inspection. Sealant replacement is recommended by a qualified person as needed. Monitor annually.

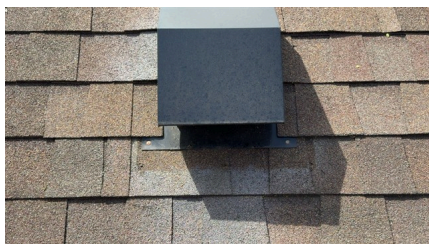
1.1 Item 3 (Picture)

(4) An exposed nail head near the chimney vent was observed at the time of inspection. Recommend sealant by a qualified roofing contractor or person as needed..

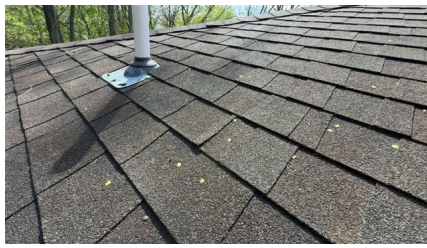
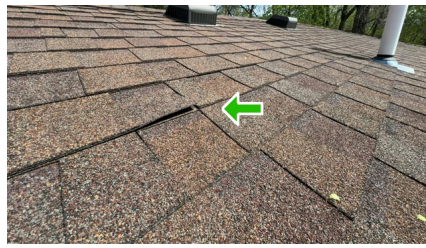
(5) A lifted or exposed shingle was observed at the time of inspection, likely due to loss of bonding/seal adhesion.

- maintenance or sealant as needed to reduce moisture entry long term.

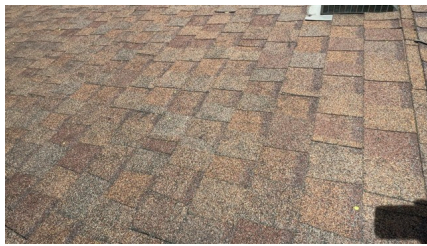
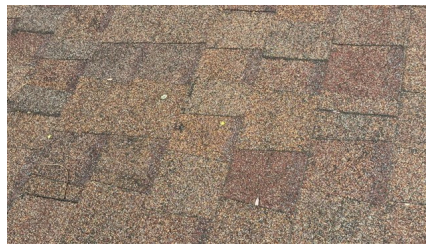
(6) General granule loss consistent with age-related wear was observed at the time of inspection. The remaining service life cannot be precisely determined; however, the roof appears to be approximately at or beyond mid-life. Recommend continued monitoring.

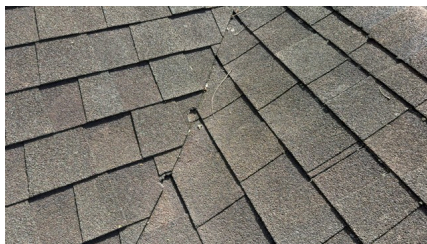
1.1 Item 8 (Picture)

(7) Localized rip/tear was observed at the valley at the time of inspection, with no significant underlying exposure noted. Recommend maintenance as needed long term.

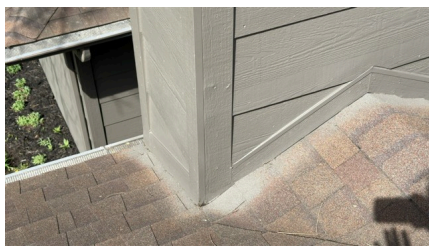
1.3 Item 1 (Picture)

No roof flashing was observed in areas, which can be common in homes of this age or construction type. Recommend evaluation by a qualified roofing contractor to determine if installation or upgrades are warranted to improve weather protection.

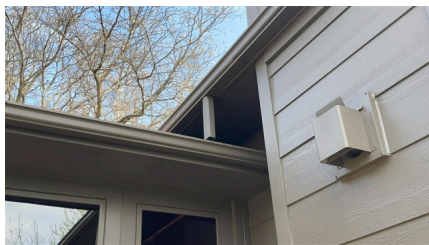
1.4 Item 1 (Picture)

- Not able to determine if leaks exist due to the absence of heavy rainfall at the time of inspection. The gutter was observed to require monitoring for drips and spills; recommend repair as needed. A partial drainage system was present and may require completion or further evaluation by a qualified contractor. Bubbling paint was also observed on the gutters and is considered cosmetic; recommend repair or refinishing as needed.

Recommend monitoring gutters during heavy rainfall and correcting as needed by a qualified person or professional.

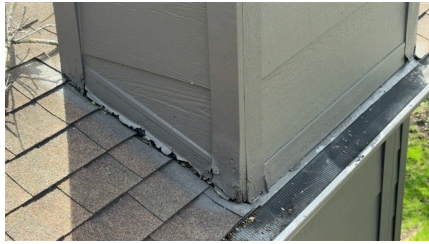
1.6 Item 1 (Picture)

(2) Wood rot deterioration was observed at the chimney area at the time of inspection. Recommend repair and/or further evaluation by a qualified professional to determine the extent of damage and appropriate corrective measures.

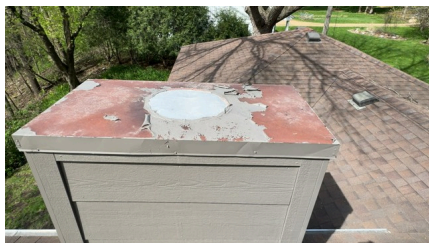
1.6 Item 2 (Picture)

(3) Peeling paint was observed on the abandoned chimney at the time of inspection. An area reliant on sealant was also observed; recommend replacement as needed by a qualified roofing contractor.

- Maintenance.
- The chimney was abandoned or covered.

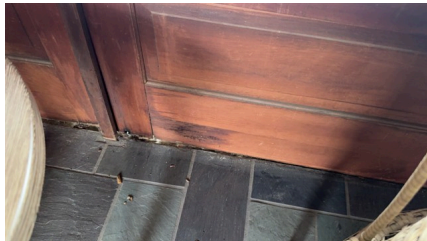
2.2 Item 1 (Picture)

(1) A localized wood, rot, or visible light gap was observed at the breezeway between the house and the garage at the time of inspection. This condition, which appears to have commenced through age, is recommended for repair by a qualified pest control professional.

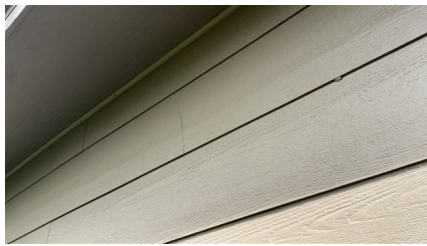
2.2 Item 5 (Picture)

(2) Cracked or split siding was observed at the time of inspection. Recommend repair or replacement by a qualified person as needed. Evaluation of manufacturer installation methods is beyond the scope of this inspection.

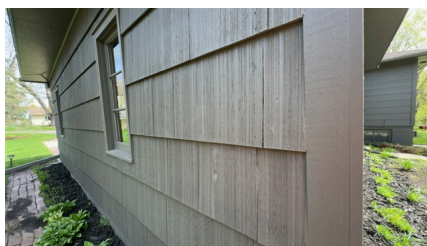
2.2 Item 9 (Picture)

(3) Siding was observed to be in need of general maintenance at the time of inspection, consistent with normal wear and tear. Recommend routine maintenance by a qualified person as needed to help extend the service life of the siding.

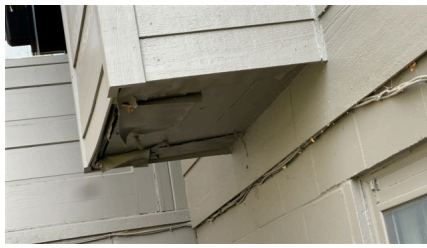
2.2 Item 10 (Picture)

(4) An exposed area was observed at the rear of the home under the chimney area at the time of inspection. Further evaluation and repair is recommended by a qualified roofing contractor to prevent potential moisture intrusion.

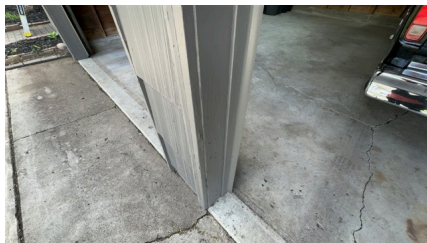
(2) A small amount of peeling paint was observed on the exterior garage door trim at the time of inspection. Recommend repair and repainting by a qualified person as needed.

2.5 Item 1 (Picture)
garage door trim

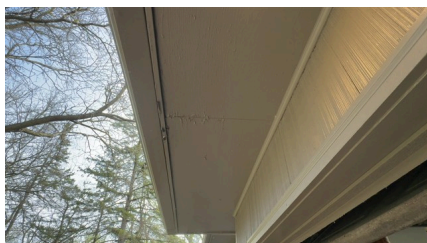
2.5 Item 2 (Picture)

(3) Peeling paint was observed in some visible soffit areas at the time of inspection. Monitor adjacent gutters for potential dripping or overflow, and recommend repair or maintenance by a qualified person as needed.

- 3 or more areas peeling paint.
- Comments on visual areas only. hidden damages may exist.

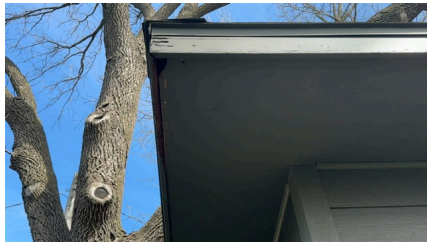
2.5 Item 3 (Picture)

(4) Wood rot was observed that may provide potential entry points for rodents. Recommend repair and/or further evaluation by a qualified pest control professional.

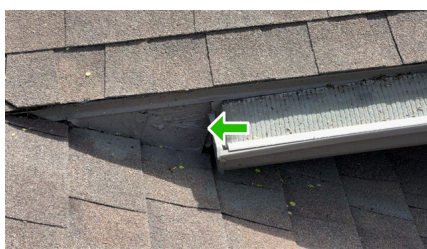
2.5 Item 4 (Picture)

(5) Exposed fasteners and an exposed area were observed on trim near the roof, which may allow for moisture entry. Recommend repair by a qualified person as needed.

- materials end of life span.

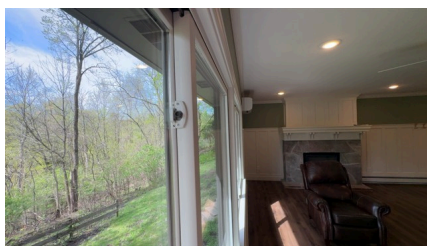
2.7 Item 1 (Picture)

(1) Missing hardware was observed in a localized area of the window at the time of inspection. Recommend installation or repair by a qualified person as needed.

- A lack of screens was observed at the time of inspection. Recommend installation or replacement by a qualified person as needed.

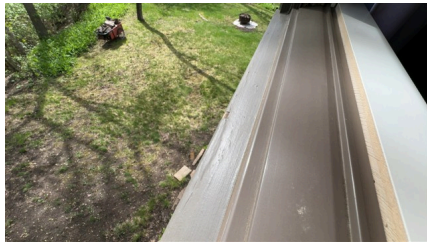
2.7 Item 2 (Picture)

(2) Item 2 (Picture) A small amount of localized, peeling paint was observed on the window trim at the time of inspection. Recommend replacement by a qualified person as needed.

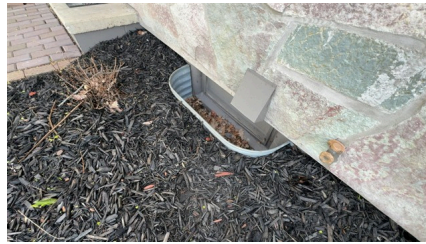
2.7 Item 3 (Picture)

- Item 3 (Picture) Peeling paint was observed on the basement windows at the time of inspection. General maintenance is recommended by a qualified person as needed.

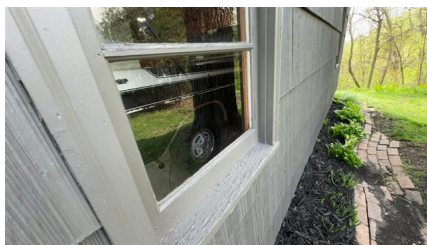
(4) Wear and tear, localized dry stains, and peeling paint were observed on the garage windows at the time of inspection. Recommend maintenance by a qualified person as needed.

- Common in homes of this age.

2.7 Item 4 (Picture)
both garage windows

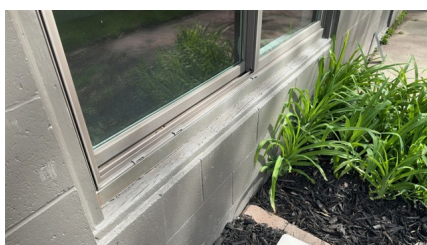
2.7 Item 5 (Picture)

(5) Cracked sealant at the window and peeling paint were observed at the time of inspection. Recommend general maintenance or repair by a qualified person.

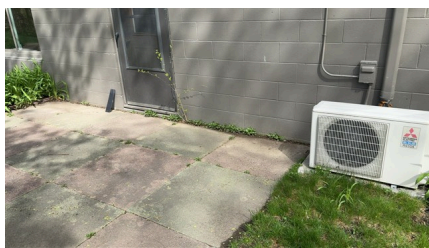
2.9 Item 1 (Picture)

(1) Cracks (1/4 inch or less) were visible in the sidewalk at the time of the inspection. Cracks exceeding 1/4 inch should be patched with an appropriate sealant by a qualified person to avoid continued damage to the walkway surface from freezing moisture.

(2) Water was observed draining towards the home at the time of inspection. Monitoring for water is recommended.

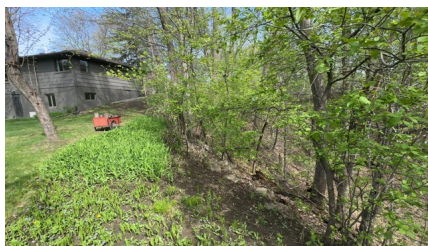
2.10 Item 1 (Picture)

(1) No erosion was observed on the front, rear, or river-side areas of the home at the time of inspection. Recommend continued long-term monitoring for any changes.

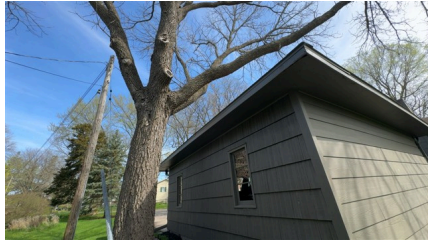
2.10 Item 2 (Picture)

(2) A large overhanging tree was observed at the time of inspection. Recommend trimming, maintenance, or further evaluation by a qualified professional as needed.

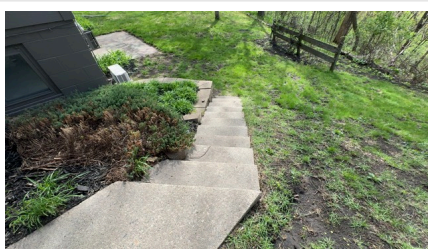
2.17 Item 1 (Picture)

A lack of a handrail for the exterior stairs was observed at the time of inspection. Recommend installation by a qualified person for safety.

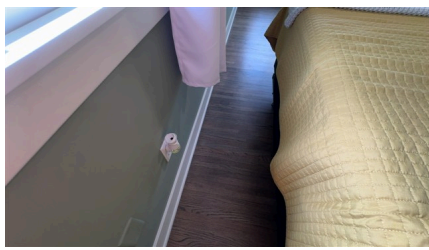
3.6 Item 1 (Picture)

Deodorizers were observed in use at the time of inspection. Recommend further evaluation by a qualified person as needed.

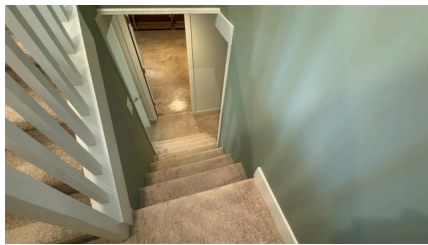
3.10 Item 1 (Picture)

A lack of a hand drill leading to the basement was observed at the time of inspection, and installation is recommended by a qualified person for safety.

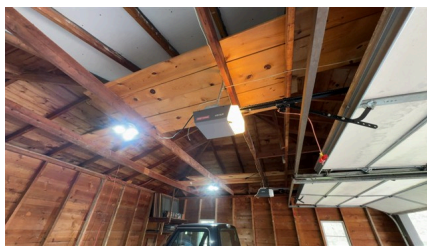
4.0 Item 1 (Picture)

(2) A lack of a dedicated electrical receptacle for garage door openers over the overhead automatic was observed at the time of inspection. Consider installation or further evaluation by a licensed electrician.

- This would not meet modern standards.

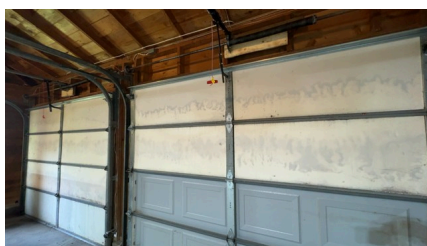
4.0 Item 2 (Picture)

(3) Staining was observed on the garage door at the time of inspection. The source should be monitored and corrected as needed if changes occur. Partial insulation was also observed in the area.

- Dry at time.

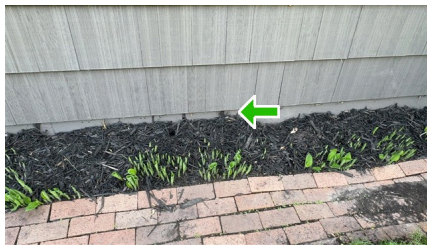
4.2 Item 1 (Picture)

An exposed gap with missing mortar was observed at the time of inspection on the exterior garage wall in a localized area, which was sealed to reduce moisture. The source should be monitored for changes and corrected as needed. Common Maintenance as needed.

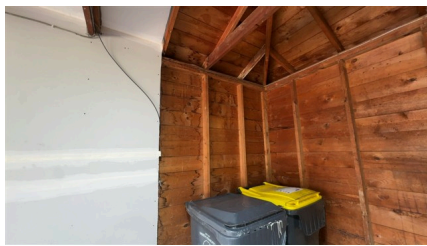
4.3 Item 1 (Picture)

Localized stains were observed on the garage wall and ceiling, which were dry at the time of inspection, common in homes of this age. The source should be monitored for changes and corrected as needed. Recommend repair as needed.

- Area dry at time.

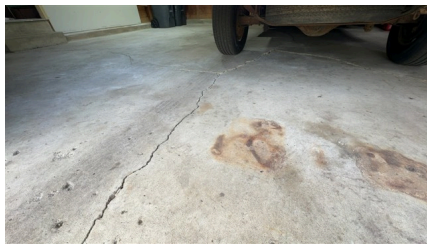
4.6 Item 1 (Picture)

(1) Settlement cracks and localized displacement were observed at the garage floor at the time of inspection; however, visibility was limited due to personal items. These areas should be monitored for changes, and repair is recommended as needed.

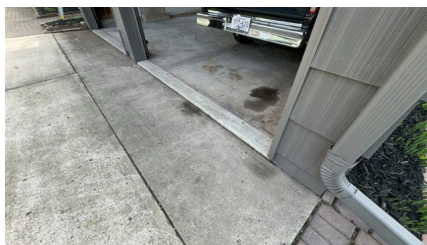
4.6 Item 2 (Picture)

(2) A potential trip hazard was observed at the garage, with more than 1 inch between the garage and driveway, at the time of inspection. Recommend repair by a qualified person for safety, and monitor for water that drains toward the home.

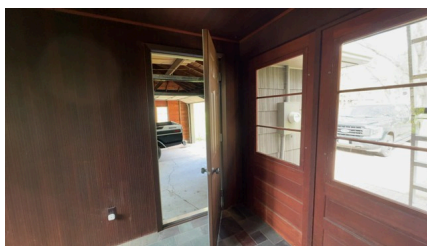
4.7 Item 1 (Picture)

Determining if the firewall meets local jurisdiction or code requirements was not possible at the time of inspection. A fire, safety, or code inspection for the firewall is recommended by a qualified person or contractor as needed.

- Lack of self-closing hinges was observed at the time of inspection. Installation is recommended by a qualified person as needed.

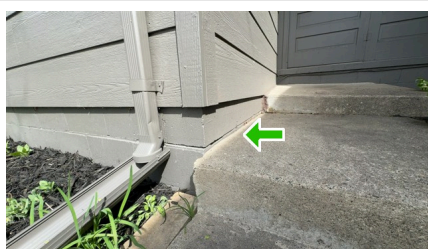
Missing mortar with an exposed gap was observed at the time of inspection, with no major displacement or settlement. Recommend sealing to reduce moisture entry by a qualified person as needed.

- General maintenance.

5.0 Item 1 (Picture)
rear of home

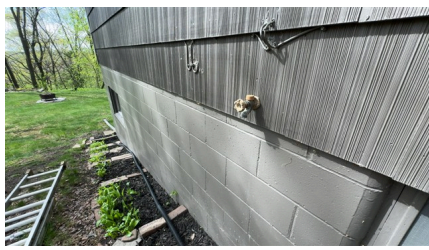
6.2 Item 1 (Picture)

(2) The water spigot was observed to be off or not respond responding at the time of inspection. Further evaluation and repair are recommended by a licensed plumber.

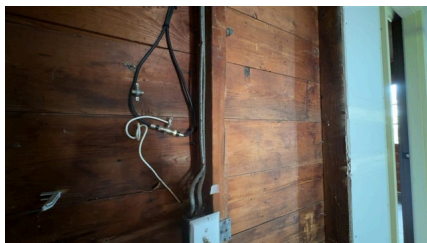
7.1 Item 1 (Picture)

(2) Aged electrical components were observed at the time of inspection, which is common in homes of this age. This information is provided for your awareness.

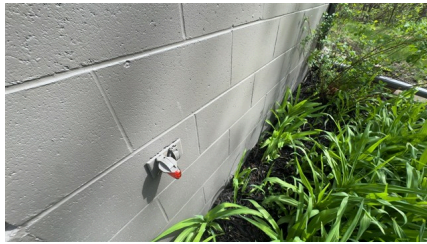
7.3 Item 1 (Picture)

- Item 1 (Picture) A lack of GFCI protection was observed for the exterior outlet at the time of inspection. The loose outlet may allow for moisture entry; recommend repair by a licensed electrician.

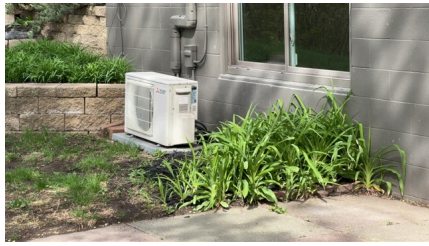
8.6 Item 3 (Picture)

(2) A mini split unit was observed to be up level at the time of inspection. Repair to slope is recommended by a licensed HVAC contractor, as this may decrease its lifespan.

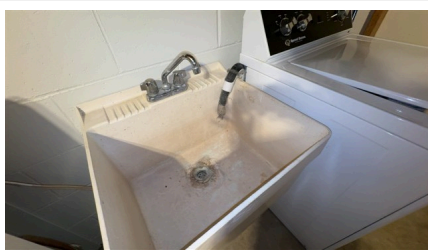
12.4 Item 1 (Picture)

The washing machine was observed draining into the sink at the time of inspection. This is a non-modern configuration; no upgrade is required as part of this inspection.

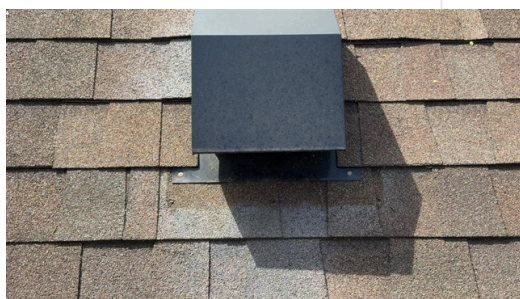
1.1 Item 3 (Picture)

(4) An exposed nail head near the chimney vent was observed at the time of inspection. Recommend sealant by a qualified roofing contractor or person as needed..

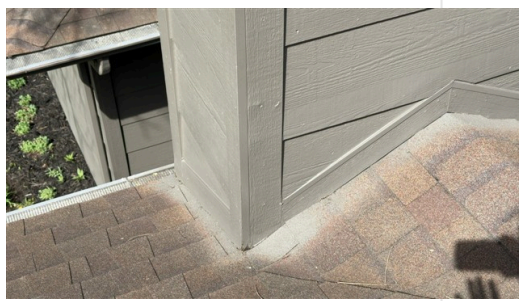
1.3 Item 1 (Picture)

No roof flashing was observed in areas, which can be common in homes of this age or construction type. Recommend evaluation by a qualified roofing contractor to determine if installation or upgrades are warranted to improve weather protection.

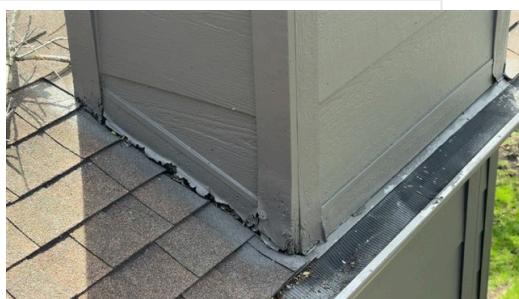
1.6 Item 1 (Picture)

(2) Wood rot deterioration was observed at the chimney area at the time of inspection. Recommend repair and/or further evaluation by a qualified professional to determine the extent of damage and appropriate corrective measures.

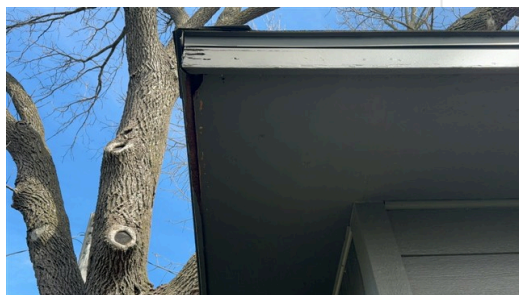
2.5 Item 3 (Picture)

(4) Wood rot was observed that may provide potential entry points for rodents. Recommend repair and/or further evaluation by a qualified pest control professional.

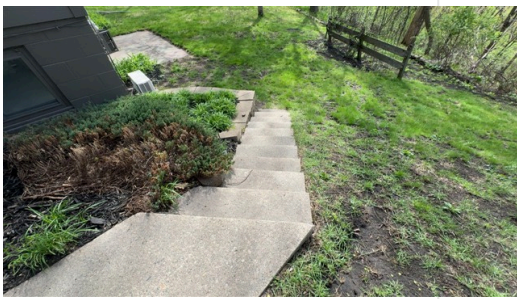
2.17 Item 1 (Picture)

A lack of a handrail for the exterior stairs was observed at the time of inspection. Recommend installation by a qualified person for safety.

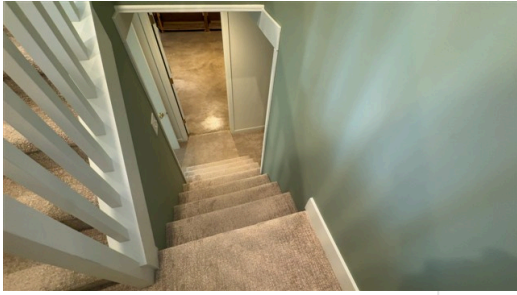
3.10 Item 1 (Picture)

A lack of a hand drill leading to the basement was observed at the time of inspection, and installation is recommended by a qualified person for safety.

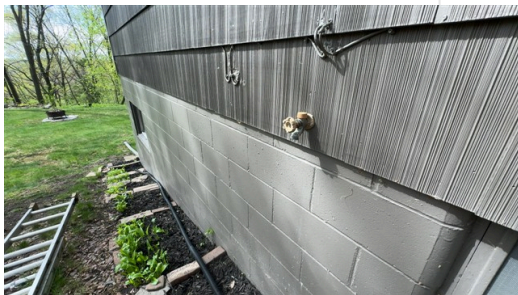
6.2 Item 1 (Picture)

(2) The water spigot was observed to be off or not respond responding at the time of inspection. Further evaluation and repair are recommended by a licensed plumber.

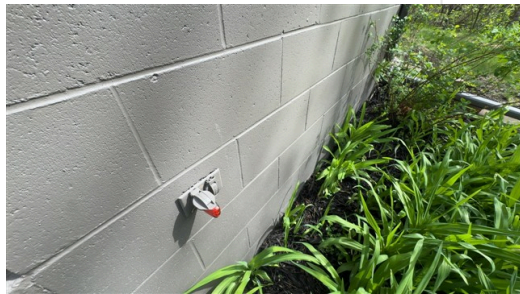
7.3 Item 1 (Picture)

- Item 1 (Picture) A lack of GFCI protection was observed for the exterior outlet at the time of inspection. The loose outlet may allow for moisture entry; recommend repair by a licensed electrician.

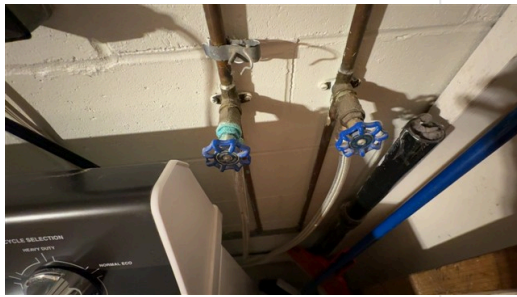
12.2 Item 1 (Picture)

(1) A small amount of corrosion was observed at the washing machine, which appeared dry at the time of inspection. Recommend repair or further evaluation by a licensed plumber.
