INSPECTION REPORT
8042 Oak Grove Road
Bloomington, MN

INSPECTED BY
Home Inspector Bloomington
Home Inspector Bloomington LLC
Home Inspector Bloomington LLC

4/29/2026

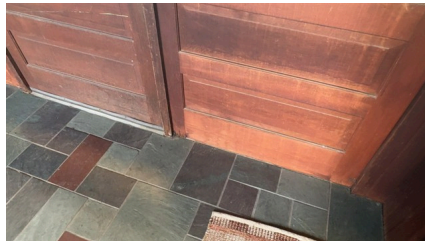
2.2 Item 1 (Picture)

(1) A localized wood, rot, or visible light gap was observed at the breezeway between the house and the garage at the time of inspection. This condition, which appears to have commenced through age, is recommended for repair by a qualified pest control professional.

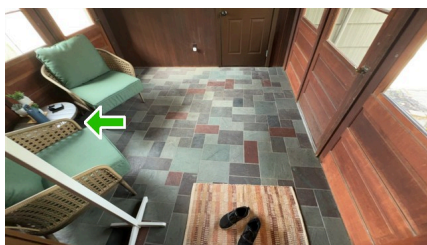
2.2 Item 3 (Picture)

- Item 3 (Picture) A lack of flashing between wooden components was observed at the time of inspection. The area should be monitored for changes and moisture, and corrected as needed.

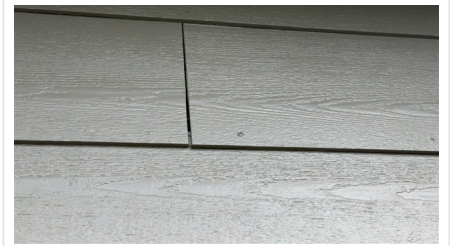
2.2 Item 6 (Picture)

- Item 6 (Picture) Seams were observed to be larger than others, and fasteners were under driven or

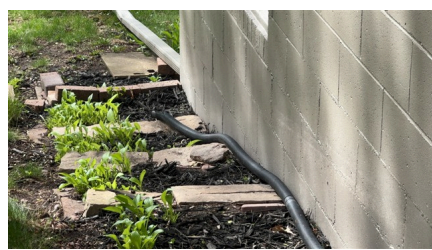
6.4 Item 1 (Picture)

(2) The sump pump discharge was observed to drain less than 6 feet from the home at the time of inspection. Recommend extending the discharge to drain 6 feet or more from the home by a qualified person as needed.

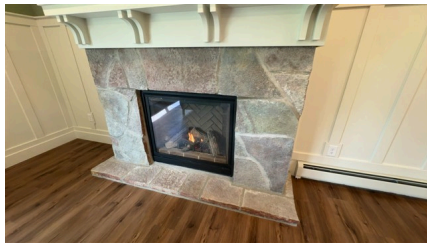
8.5 Item 1 (Picture)

(1) The gas fireplace requires invasive, technically exhaustive measures that exceed the scope of the General Home Inspection.

- Recommend service by a qualified contractor on a regular maintenance basis and before your first use. Find a CSIA-certified inspector near you at <http://www.csia.org/search>
- A gas fireplace was observed based on visual areas only at the time of inspection. Annual maintenance for all gas appliances is recommended by a licensed HVAC contractor. Tested in working order at time.

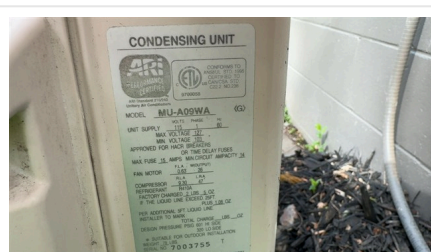
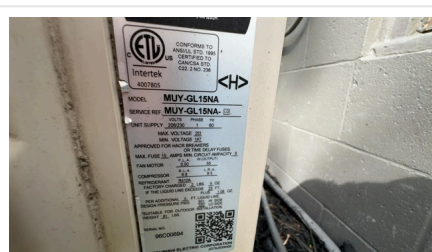
(1) The air conditioning unit was tested under normal operation; however, a thorough evaluation requires intrusive testing by a qualified HVAC technician.

- The air-conditioning system was not tested because the outside temperature was below 67 degrees F. and to test it would risk damaging the coils. The Inspector recommends evaluation and service by a qualified HVAC technician to more accurately determine the AC's condition and ensure that it is in the best possible working condition on an annual basis.
- No central air conditioner
- Consider home warranty for peace of mind <https://bit.ly/4bhcjBK>

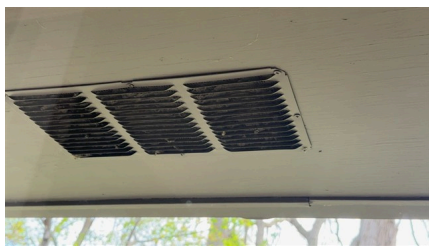
9.3 Item 1 (Picture)

- (1) Attic ventilation performance throughout the year cannot be confirmed during a visual inspection. Ventilation effectiveness can vary by climate, home design, and weather conditions. Determining winter conditions such as ice damming goes beyond the scope of a home inspection.
- (2) Debris was observed in the soffit vents at the time of inspection. Cleaning is recommended by a qualified person as needed.

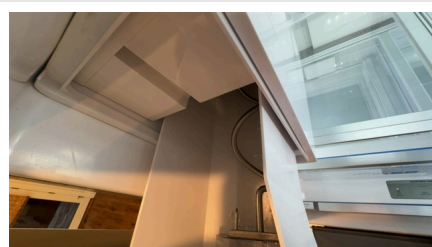
11.0 Item 1 (Picture)

(1) Ice maker was off, water supply was shut off, or the unit was not responding/connected at the time of inspection and therefore was not tested.

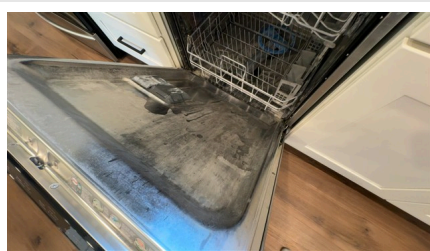
**11.3 Item 2 (Picture)**

(2) Discoloration was observed in the dishwasher, though it appeared clean at the time of inspection. Recommend monitoring and cleaning or servicing as needed.

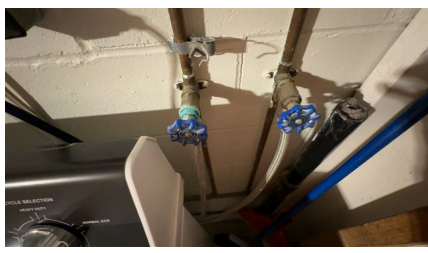
12.2 Item 1 (Picture)

(1) A small amount of corrosion was observed at the washing machine, which appeared dry at the time of

inspection. Recommend repair or further evaluation by a licensed plumber.

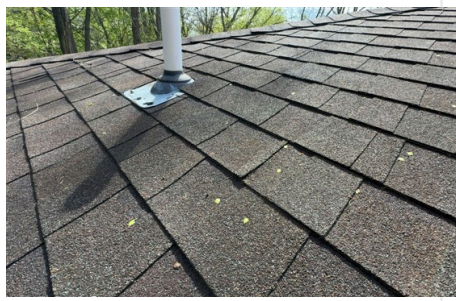
1.1 Item 4 (Picture)

(4) An exposed nail head near the chimney vent was observed at the time of inspection. Recommend sealant by a qualified roofing contractor or person as needed..

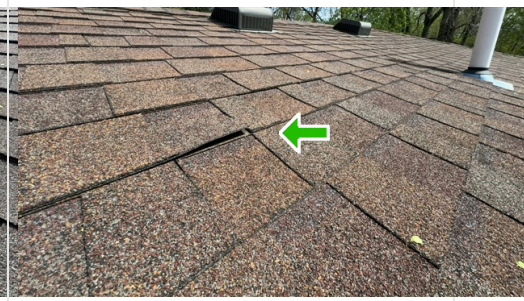
1.1 Item 5 (Picture)

(5) A lifted or exposed shingle was observed at the time of inspection, likely due to loss of bonding/seal adhesion.

- maintenance or sealant as needed to reduce moisture entry long term.

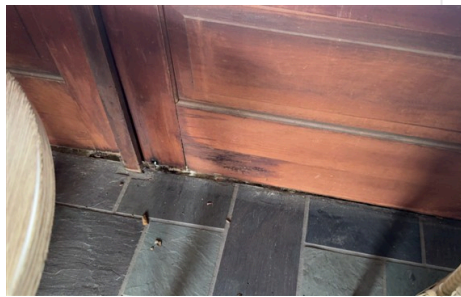
2.2 Item 1 (Picture)

(1) A localized wood, rot, or visible light gap was observed at the breezeway between the house and the garage at the time of inspection. This condition, which appears to have commenced through age, is recommended for repair by a qualified pest control professional.

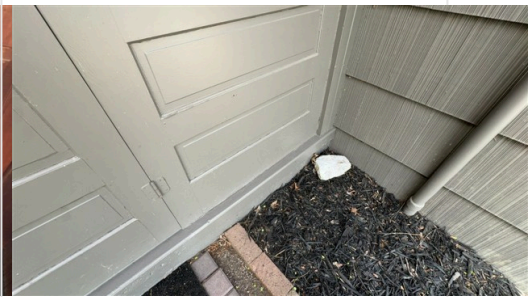
2.2 Item 3 (Picture)

- Item 3 (Picture) A lack of flashing between wooden components was observed at the time of inspection. The area should be monitored for changes and moisture, and corrected as needed.

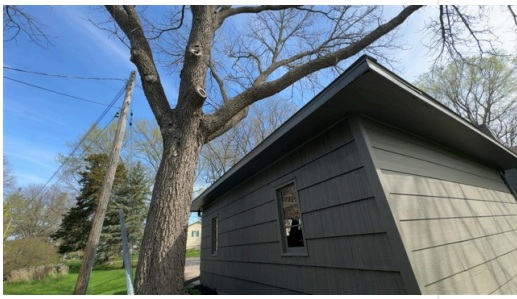
2.10 Item 2 (Picture)

(2) A large overhanging tree was observed at the time of inspection. Recommend trimming, maintenance, or

further evaluation by a qualified professional as needed.

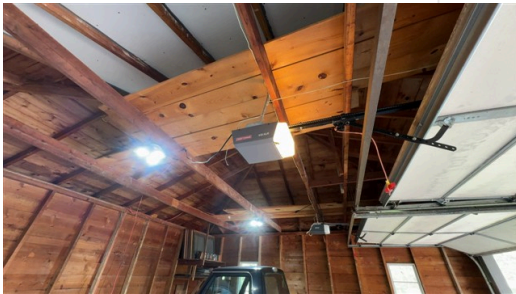
4.0 Item 1 (Picture)

(2) A lack of a dedicated electrical receptacle for garage door openers over the overhead automatic was observed at the time of inspection. Consider installation or further evaluation by a licensed electrician.

- This would not meet modern standards.

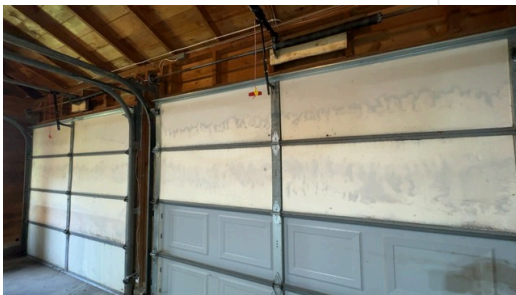
4.0 Item 2 (Picture)

(3) Staining was observed on the garage door at the time of inspection. The source should be monitored and corrected as needed if changes occur. Partial insulation was also observed in the area.

- Dry at time.

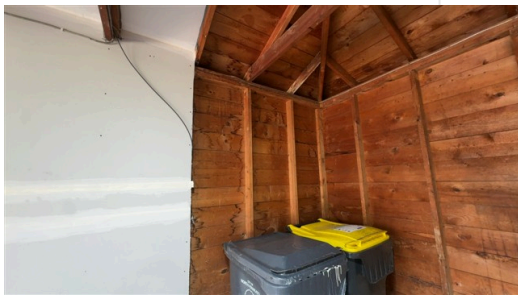
4.3 Item 1 (Picture)

Localized stains were observed on the garage wall and ceiling, which were dry at the time of inspection, common in homes of this age. The source should be monitored for changes and corrected as needed. Recommend repair as needed.

- Area dry at time.

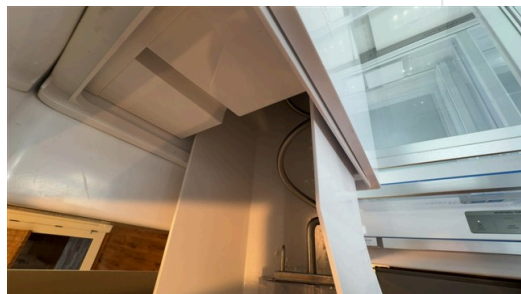
11.0 Item 1 (Picture)

(1) Ice maker was off, water supply was shut off, or the unit was not responding/connected at the time of inspection and therefore was not tested.
